## HUSQVARNA TECHNICAL BULLETIN TB1503

NOVEMBER 18, 2014

**Subject: Factory Direct Modification Campaign – Front Forks – Inspection for proper tightening torque of Piston Rod to Fork Cap**

**Affected 2015 Models: FE 350S, FE 501S**

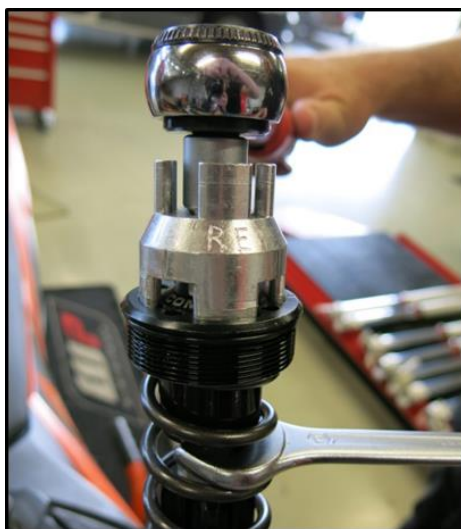
Photo 5

- On affected models, during use there is a possibility that the piston rod could loosen and become detached from the fork cap. This could cause the piston rod to become locked within the fork tube which may result in improper fork performance, potentially destabilizing the front end of the motorcycle; this could lead to an accident which could cause injury or death to the rider or others.

- It has been determined that the cause of the defect is due to a change in the production process at the fork supplier, resulting in improper tightening torque of the piston rod to the fork cap. To remedy this defect, the supplier has changed its torqueing procedure to achieve the proper tightening torque of the piston rod to the fork cap.

6. Using the special tool T14047 and a 19mm wrench, loosen the cap counter-clockwise from the piston rod nut.
7. Tighten the cap clockwise to the piston rod nut, torque to 18Nm / 13.3lb-ft. (Photo 5).
8. Using an automatic center punch only, place a "dot" on the nut indicating the repair is completed (Photo 6).
9. Steps 4-8 must be performed on both forks before assembling in reverse order of disassembly.
